Bureau of Mines Report of Investigations/1986

Report of Investigations 9009

Geotechnology in Slate Quarry Operations

By Noel N. Moebs, Gary P. Sames, and Thomas E. Marshall

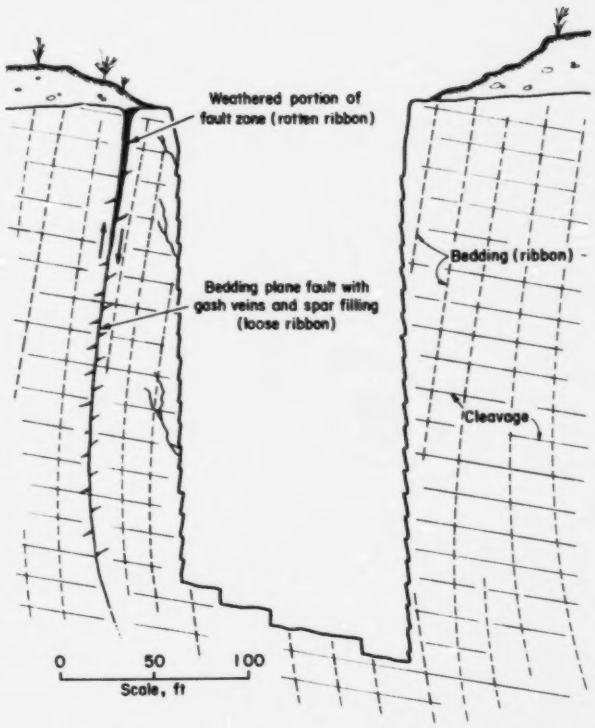
FIGURE 14. - Schematic of a "rotten ribbon" or weathered bedding plane fault.

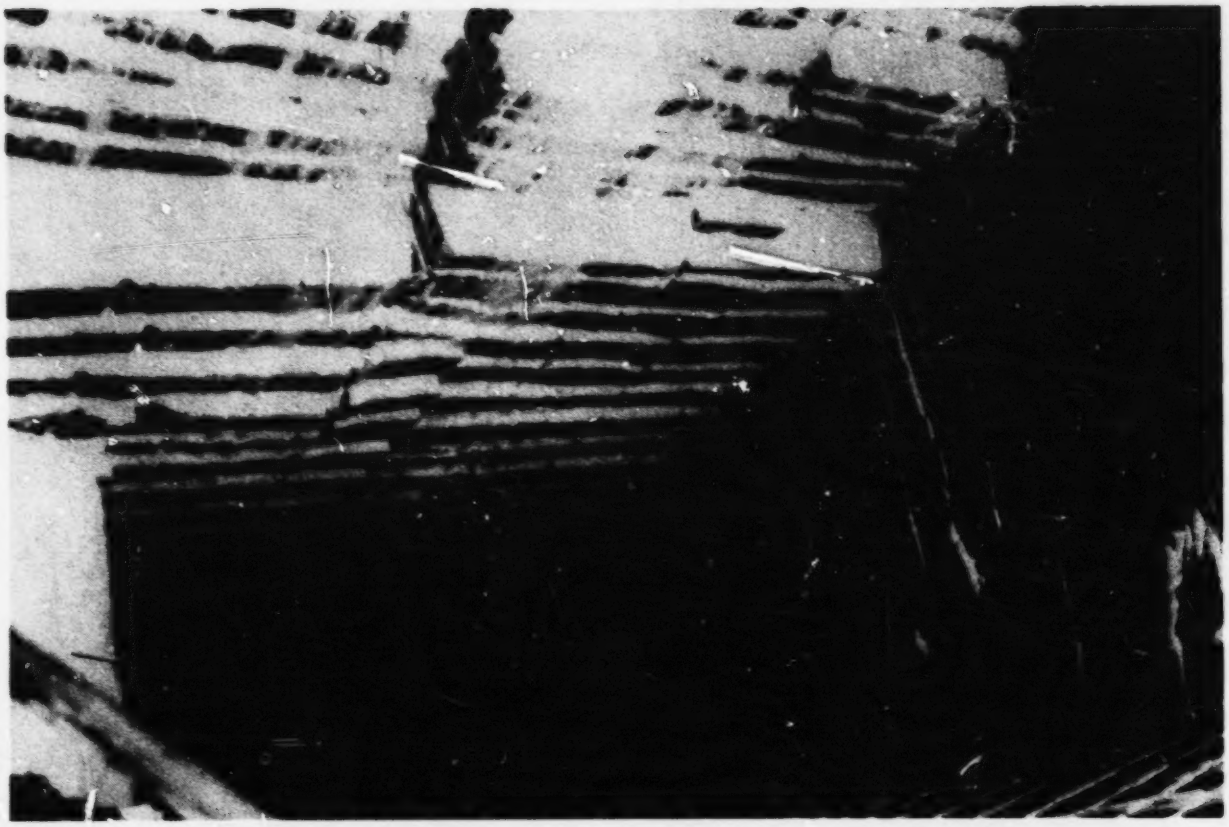
The accumulation of ice on quarry highwalls and its dislodgement because of thawing or breaking off under load constitute a serious handicap during winter operations and a hazard to quarry workers from large masses of falling ice.

The ice forms chiefly from water that seeps through cracks in the wall rock near the brink of the quarries. The ice coats virtually every surface in the quarries, the sloping floor becomes slippery and footing is uncertain, cables of various kinds are pulled from the walls by the weight of accumulated ice, and large masses of ice sometimes weighing several hundred pounds form on the quarry walls (figs. 16-18). These ice stalactites are scaled, shattered with shotgun slugs, or sometimes dynamited to avert the danger of their becoming dislodged and falling onto the quarry floor, particularly during the early spring thaw. Since slate dumps and the glacial overburden together constitute aquifers with a sizable storage capacity and since they have been removed to only a few yards from the quarry brinks, water diversion is not easily accomplished. At one quarry, three shallow dewatering wells are located on the side of the quarry and downslope from some large slate dumps. These wells, however, divert only a small portion of the ground water reaching the upper levels of the pit, and ice accumulation in the winter continues to be a severe problem.

FIGURE 16. - Early stages of ice formation on quarry highwall.

Ice control or prevention methods that have been suggested for evaluation include grouting of the quarry walls to reduce seepage, drainage drill holes, the use of a wax emulsion coating on the rock walls to prevent the adherence of ice, and suspended movable chains to break up accumulations of ice at critical areas. To date, only one of these methods, wax emulsion, has been assessed by the Bureau. The wax emulsion failed to substantially reduce ice adhesion in preliminary laboratory tests. Another method, grouting of quarry walls to reduce seepage, could have the adverse effect of increasing to an excessive level the hydraulic head in a water-filled joint or fault. At the present time, ice buildup during the winter continues to be a serious problem.

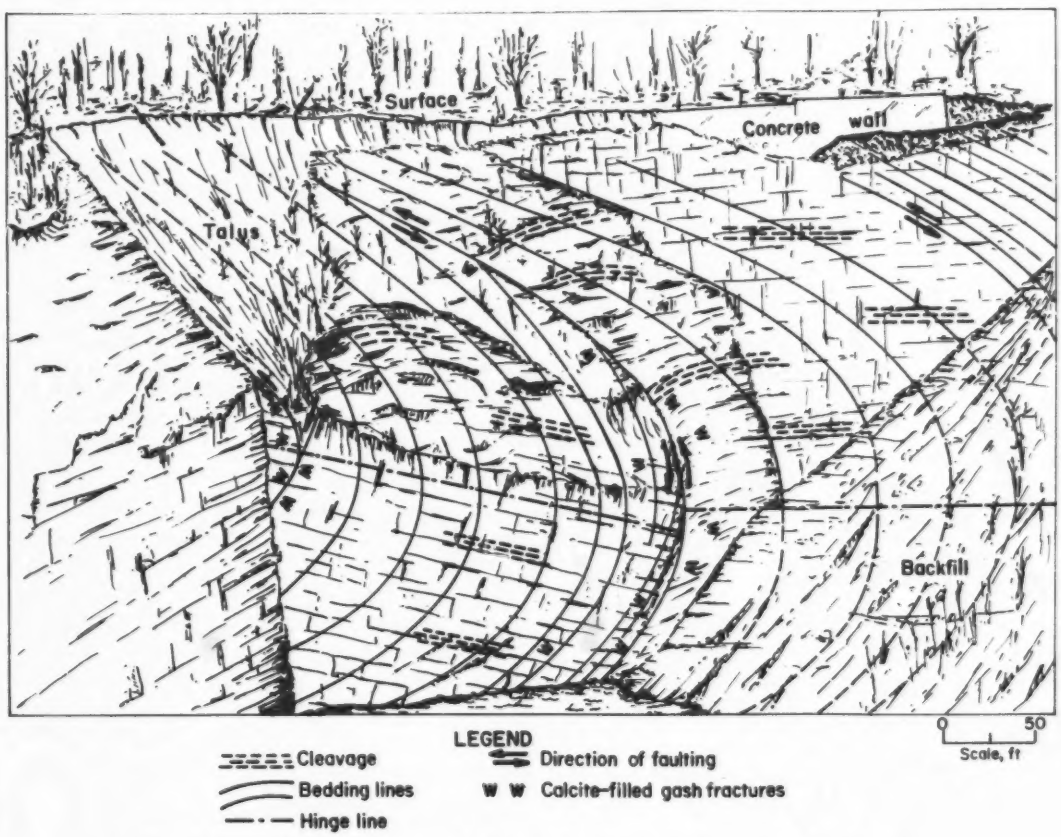
FIGURE 22. - Profile of quarry highwall showing complex geologic structures.

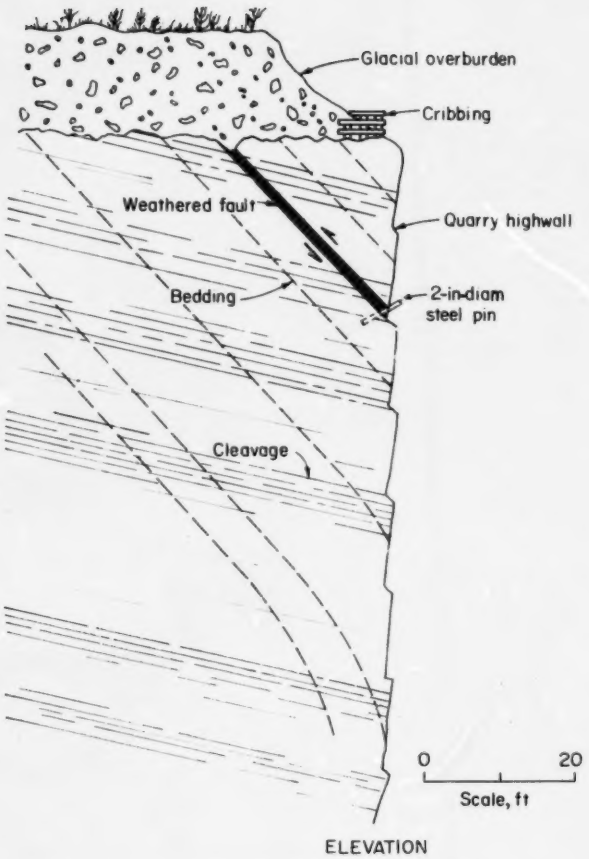
This brief discussion of geologic mapping demonstrates that the most common cause of highwall failure in the Pen Argyl district, the bedding slip fault, is a mappable feature, especially when weathered. The bedding slip fault therefore provides a target for ground control measures, surveillance, or warning systems based on the detection of incipient movement as described in the section "Strain Gauge Instrumentation." While quarries are usually aware of the hazards of bedding slip faults during development, once these structures are penetrated and exposed in the upper inaccessible portions of a quarry (fig. 23), their presence is easily forgotten; then

FIGURE 23. - Sketch showing bedding slip fault near brink of quarry.

some method for monitoring the stability of the faulted area is essential.

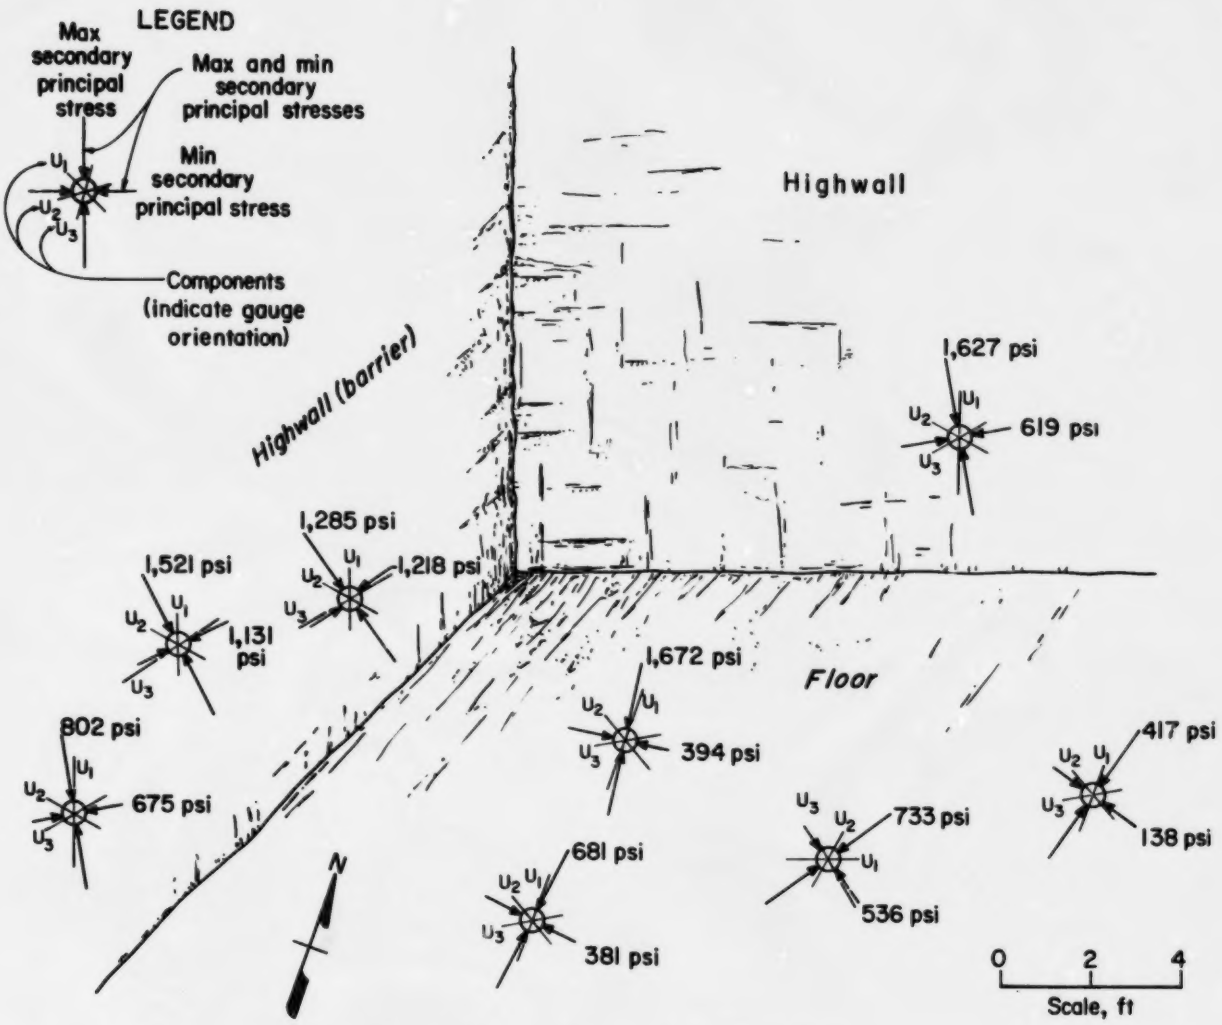
Figure 29 shows the measurements obtained at depths of about 24 in beneath exposed quarry surfaces. Theoretical values calculated for expected vertical and horizontal stress in gravity-loaded rock strata are 550 and 103 psi, respectively. Stress values determined by overcoring measurements, as shown in figure 29, are all well above the theoretical values: an average maximum 1,203 psi

FIGURE 29. - Diagram of quarry stresses.

and minimum 1,008 psi, in the barrier highwall; an average maximum 1,627 psi and minimum 619 psi, in the quarry highwall; and an average maximum 876 psi and minimum 362 psi, in the floor. All these measured stress values are compressive.

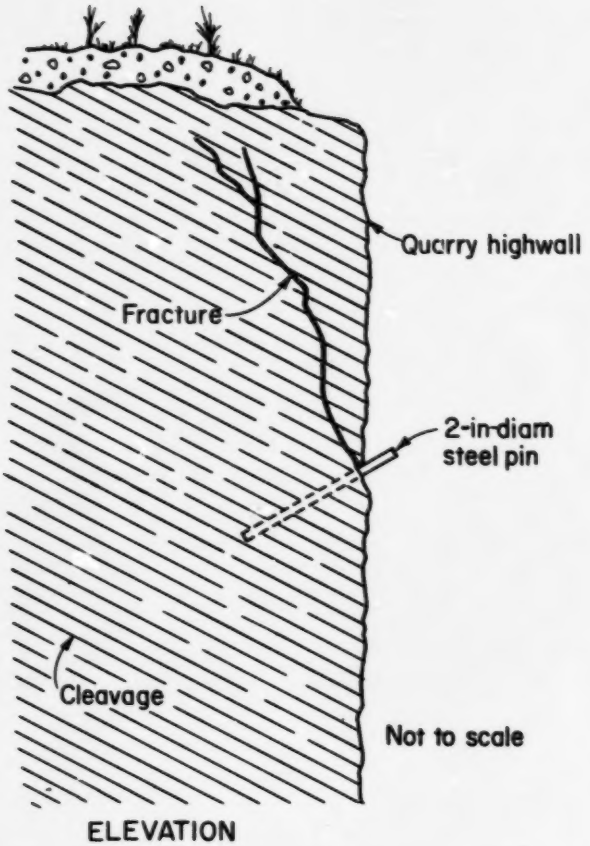
The practice of using bolts to secure rock that is weak or may become dislodged is commonplace in underground mines and some open pits but virtually unknown in slate quarrying. Instead, loose slabs in quarry highwalls that cannot be scaled are supported by steel pins inserted into downward-sloping holes drilled in the highwall (fig. 30).

FIGURE 30. - Common method of securing fractured rock on quarry highwall with steel pins.
